RESERVE STUDY REPORT

Chestnut on the Green Phase II

Indian Head Park, Illinois

WEC PROJECT #: 13C-438

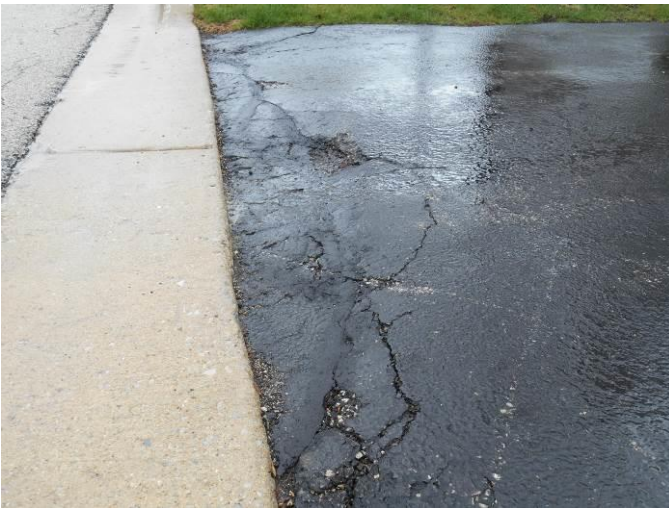
Typical asphalt deterioration.

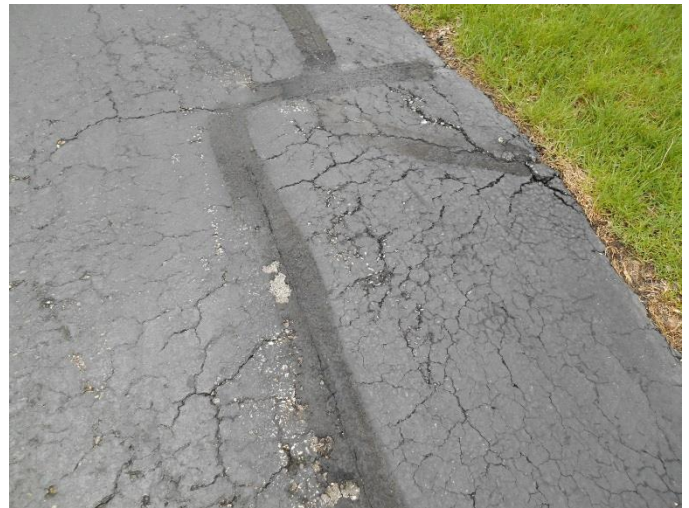
Typical asphalt deterioration.

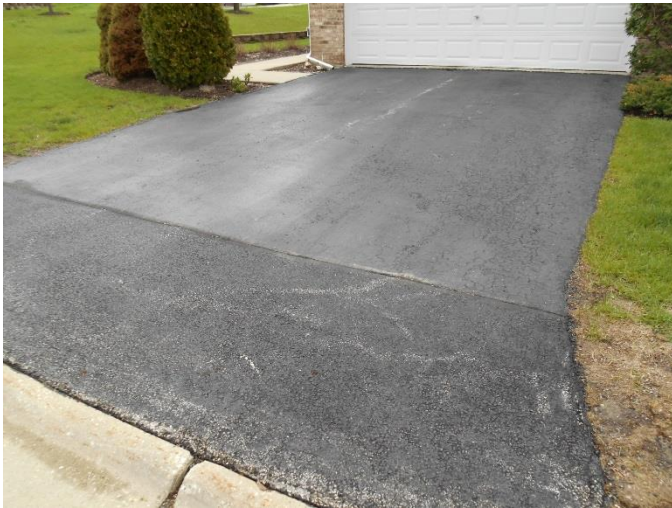
Recent driveway repair.

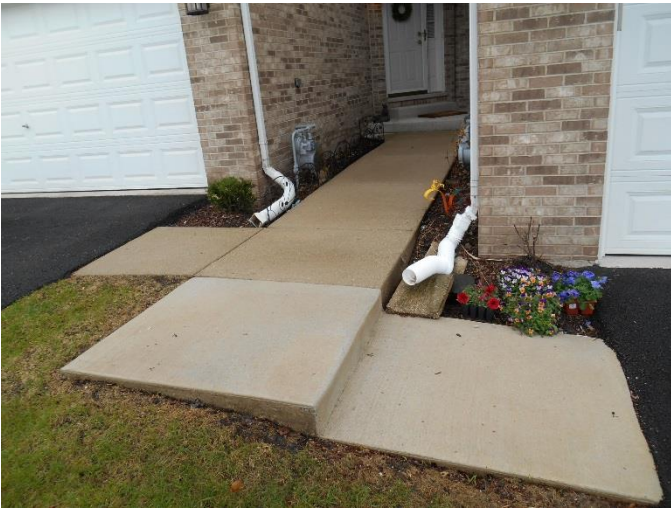
Recently repaired walkway.

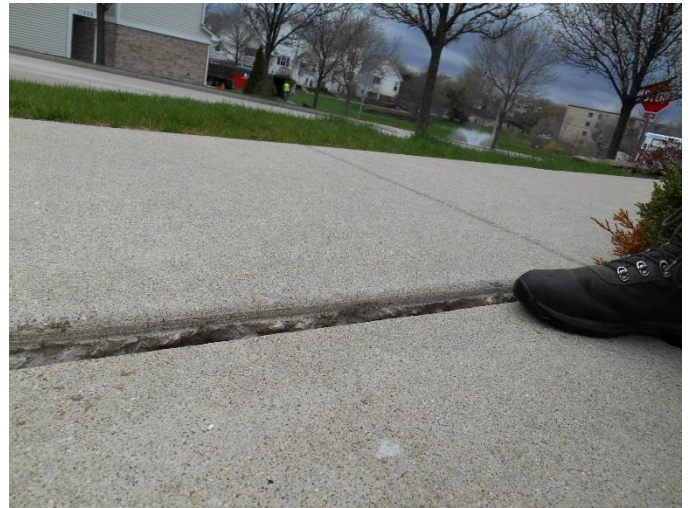
- A trip hazard was observed at the concrete entrance walkway to unit 11055. We only sampled concrete conditions; therefore, we recommend that all concrete be inspected and repaired as necessary.
- See photograph section of this report for observed deficiencies.

Trip hazard at the concrete entrance walkway to unit 11055.

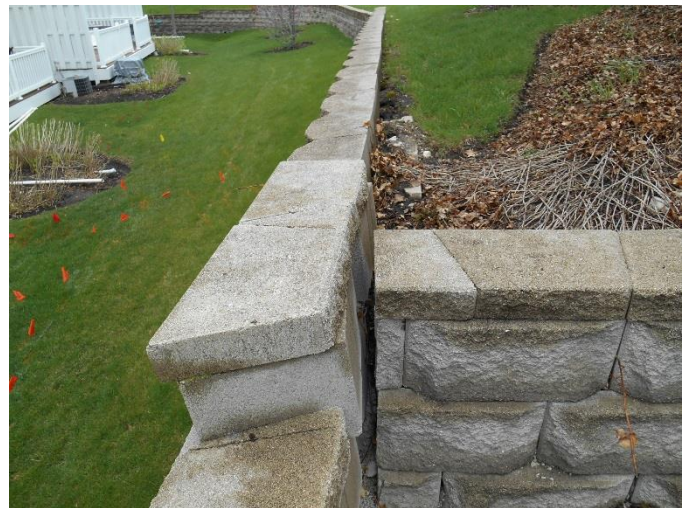
- The retaining wall along the west side of unit 11048 was in marginal condition. Lateral movement of the soil and wall were observed. The rate of movement is unknown; however, sudden movement is possible, and is a safety concern. It is recommended that the wall be repaired/re-built by a qualified contractor.
- See photograph section of this report for observed deficiencies.

The retaining wall along the west side of unit 11048 was in marginal condition. Lateral movement of the soil and wall were observed. The rate of movement is unknown; however, sudden movement is possible, and is a safety concern. It is recommended that the wall be repaired/re-built by a qualified contractor.

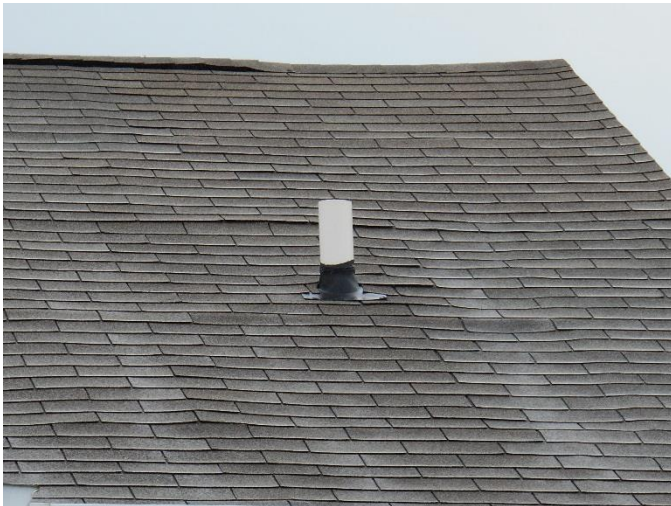
Shingles curling and not laying properly.

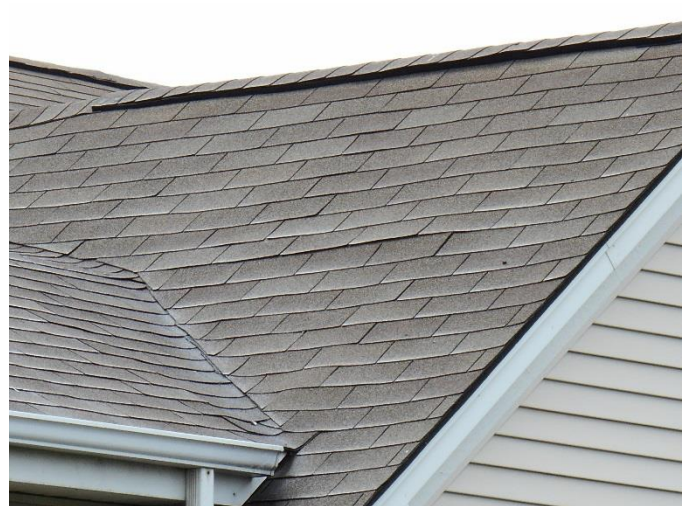
Shingles not laying properly.

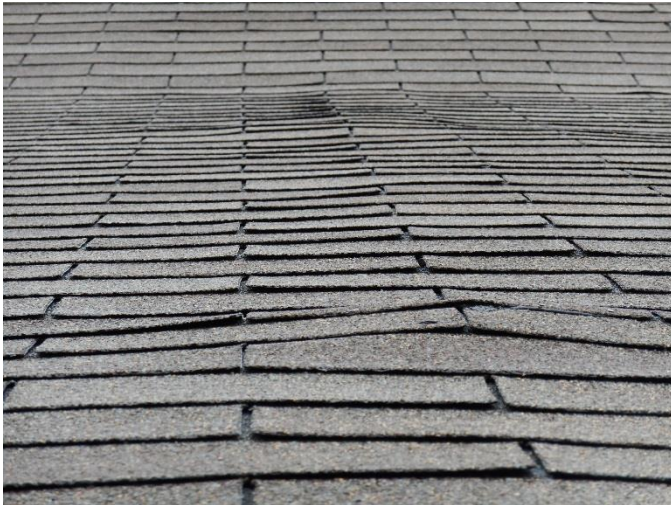
Uneven roof decking.

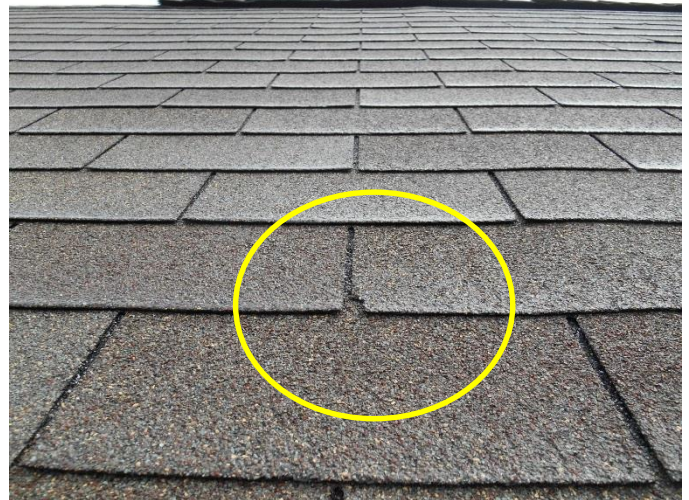
Deteriorating shingles.

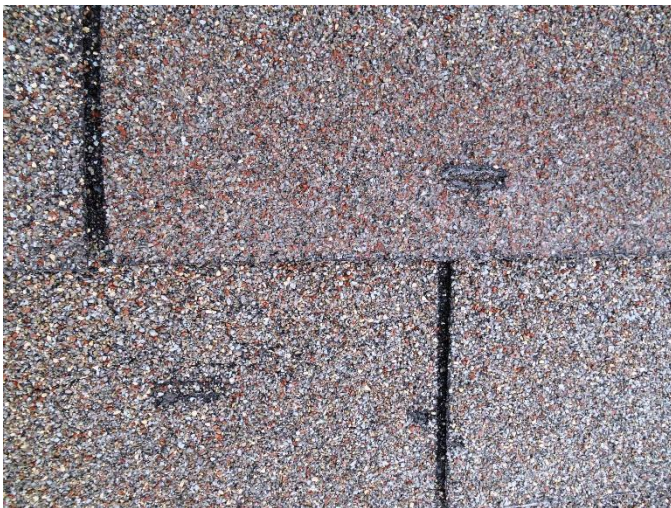
Deteriorating shingles.

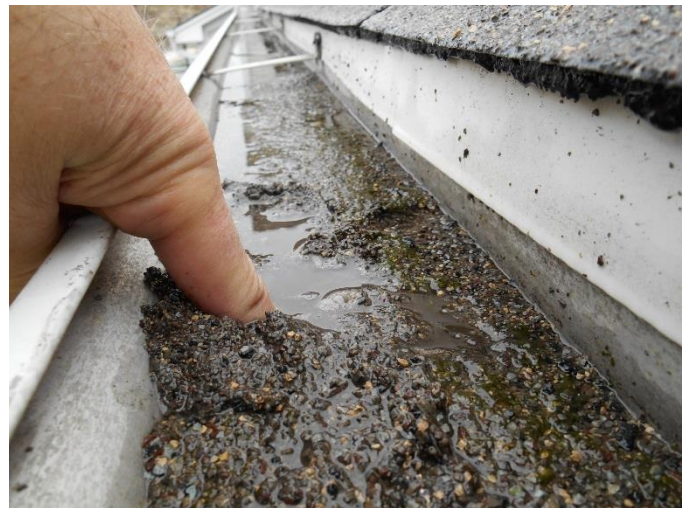
Shingle granular loss.

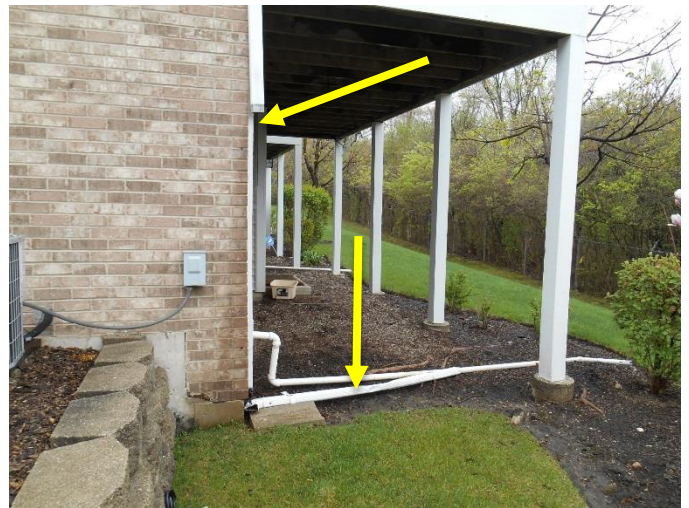
Disconnected downspout at unit 11006.

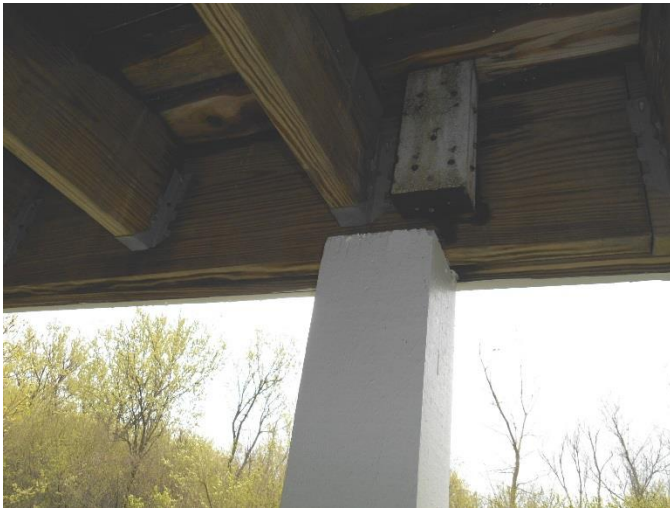
Inadequate balcony structural connection.

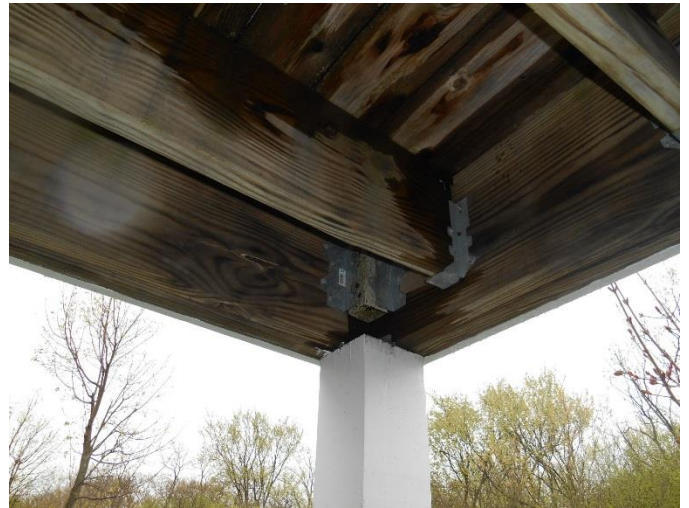
Inadequate balcony structural connection.

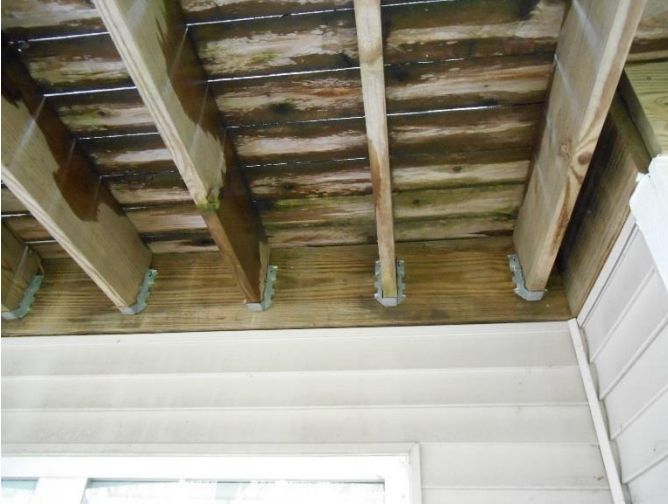
Inadequate balcony structural connection (i.e. no ledger board bolts).

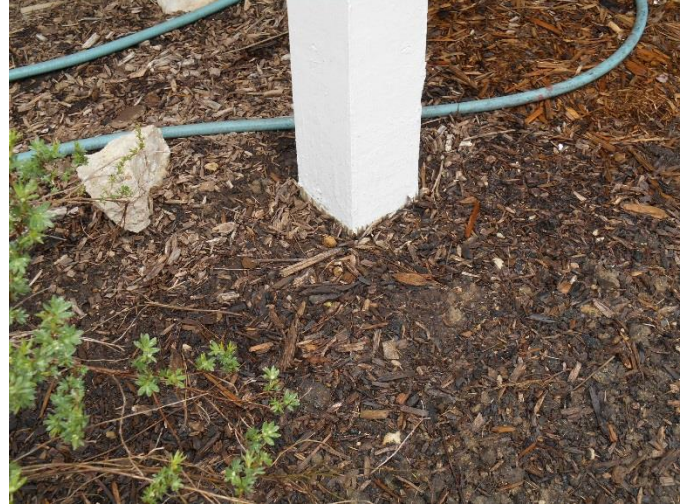
Support column below grade is subject to excessive moisture.
